Manhole Inspection Summary

Manhole # S35C__098MH

Record Plat: **35C** Node: **098** Status: **New Manhole (Not in GIS)** Insp Date: **11/17/08 12:00 AM**

Location Address: **cross from 315 n calvert st**

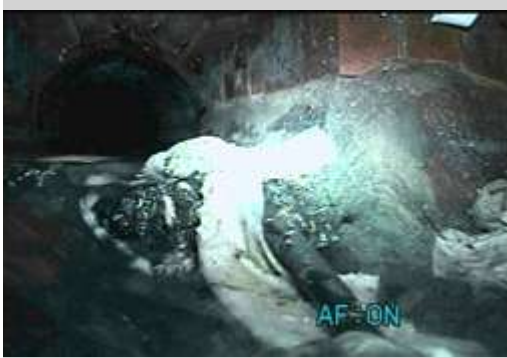
Defect 4

Condition: ☐ Sound ☐ Cracked ☐ Root Intrusion ☐ Deteriorated ☐ Leaks ☒ **Debris**

channel debris

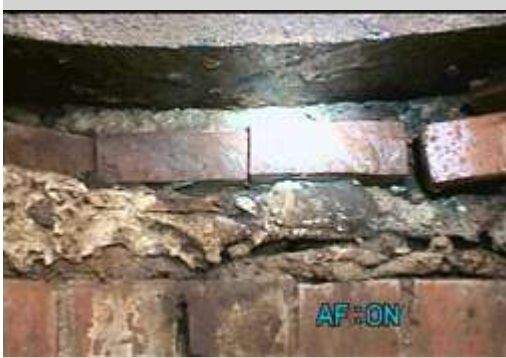
Defect 3

Condition: ☐ Sound ☐ Cracked ☐ Root Intrusion ☒ **Loose Brick** ☒ **Deteriorated**

chimney loose bricks frame adj

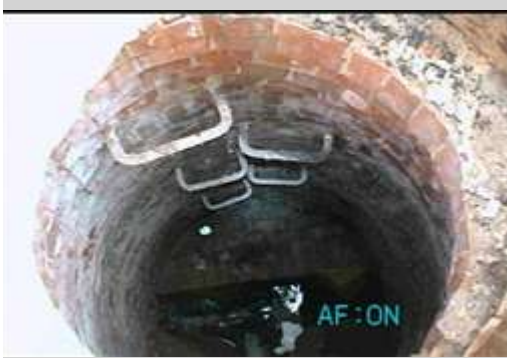
Defect 2

Count: **5** Missing: **0** ☒ **Corroded**

corr steps

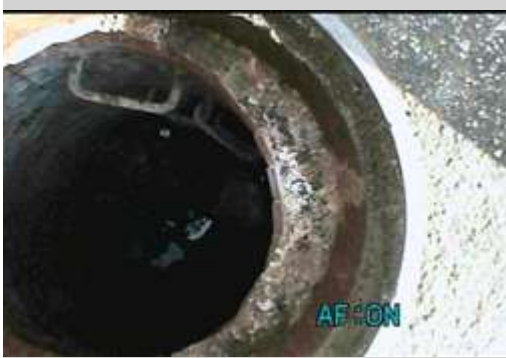
Defect 1

Offset: **2.5** (in.)

offset

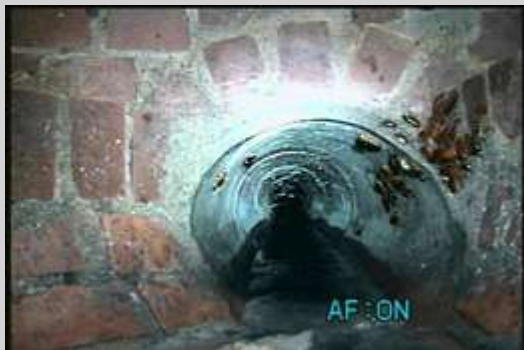
12 O'Clock Outflow

10 in. Circular Gravity Sewer
Pipe Out @ 12 O'Clock

Pipe Material: **Clay** ☐ Pipe Lined

Invert Depth: 10.13 (ft.) Flow Characteristics: **Fast**

Infiltration: **None** Pipe Seal Cond: **Unknown**

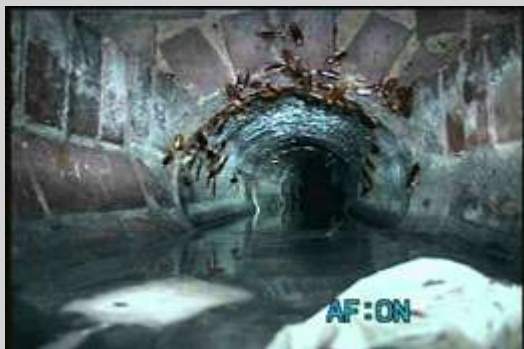
6 O'Clock Inflow

10 in. Circular Gravity Sewer
Pipe In @ 6 O'Clock

Pipe Material: **Clay** ☐ Pipe Lined

Invert Depth: 9.96 (ft.) Flow Characteristics: **Slow**

Infiltration: **None** Pipe Seal Cond: **Unknown**

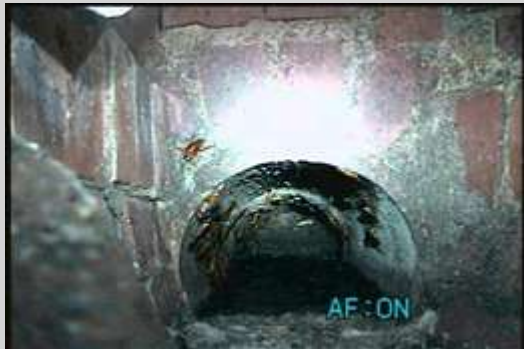
9 O'Clock Inflow

8 in. Circular Gravity Sewer

Pipe In @ 9 O'Clock

Pipe Material: **Clay** ☐ Pipe Lined

Invert Depth: **9.83** (ft.) Flow Characteristics: **Slow**

Infiltration: **None**
